VARCA VENTURES, INC., and
WILDCAT MINING CORPORATION,

CONSENT DECREE

Appendix

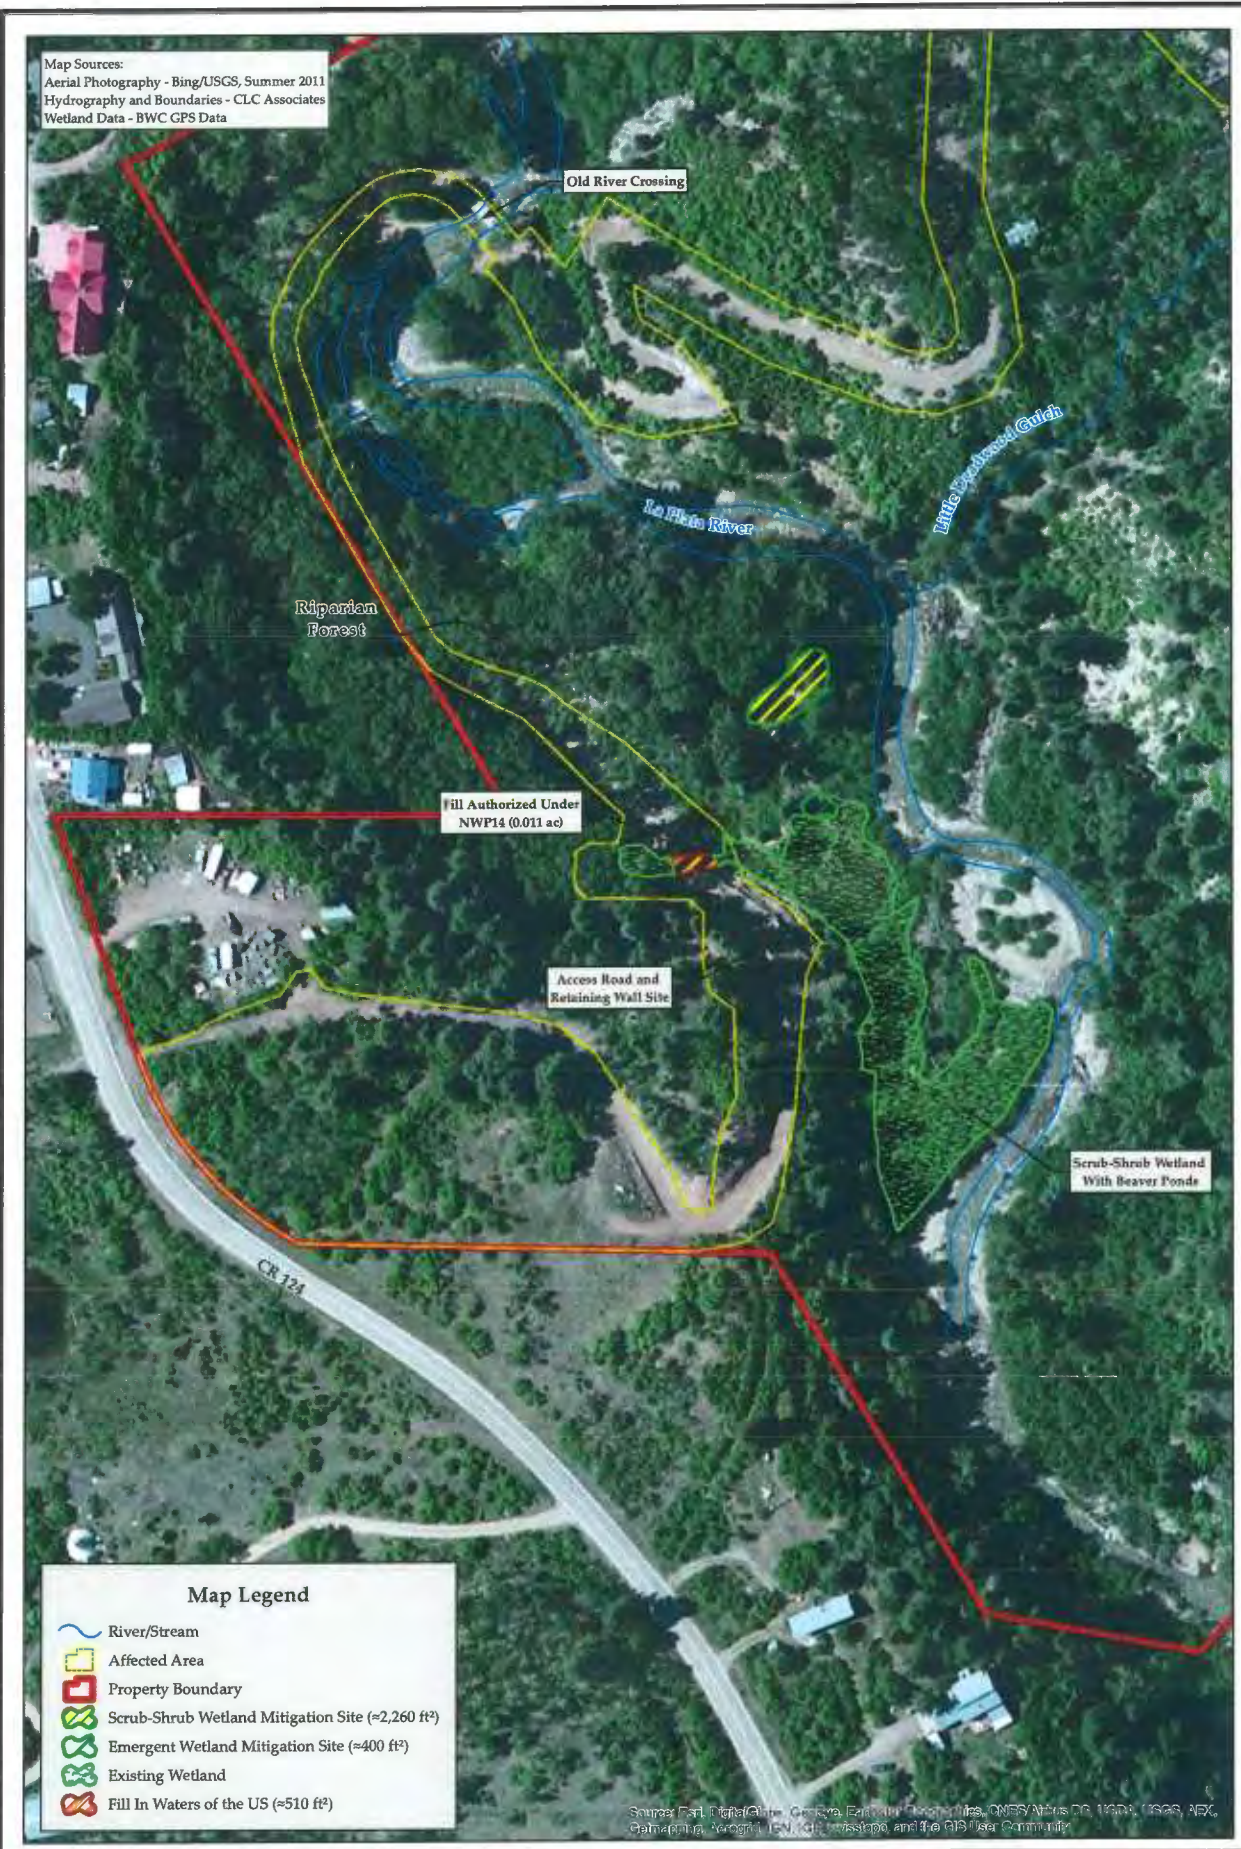
Figure
3A

May Day Mine
Existing Conditions At
Mine Access Road Site

Existing conditions at the two areas are shown on Figures 3a and 3b. (The conditions shown on Figure 3a at the Mine Access Road were those that existed in 2010 prior to completion of the work on the road.) The following sequence of work applies to both areas:

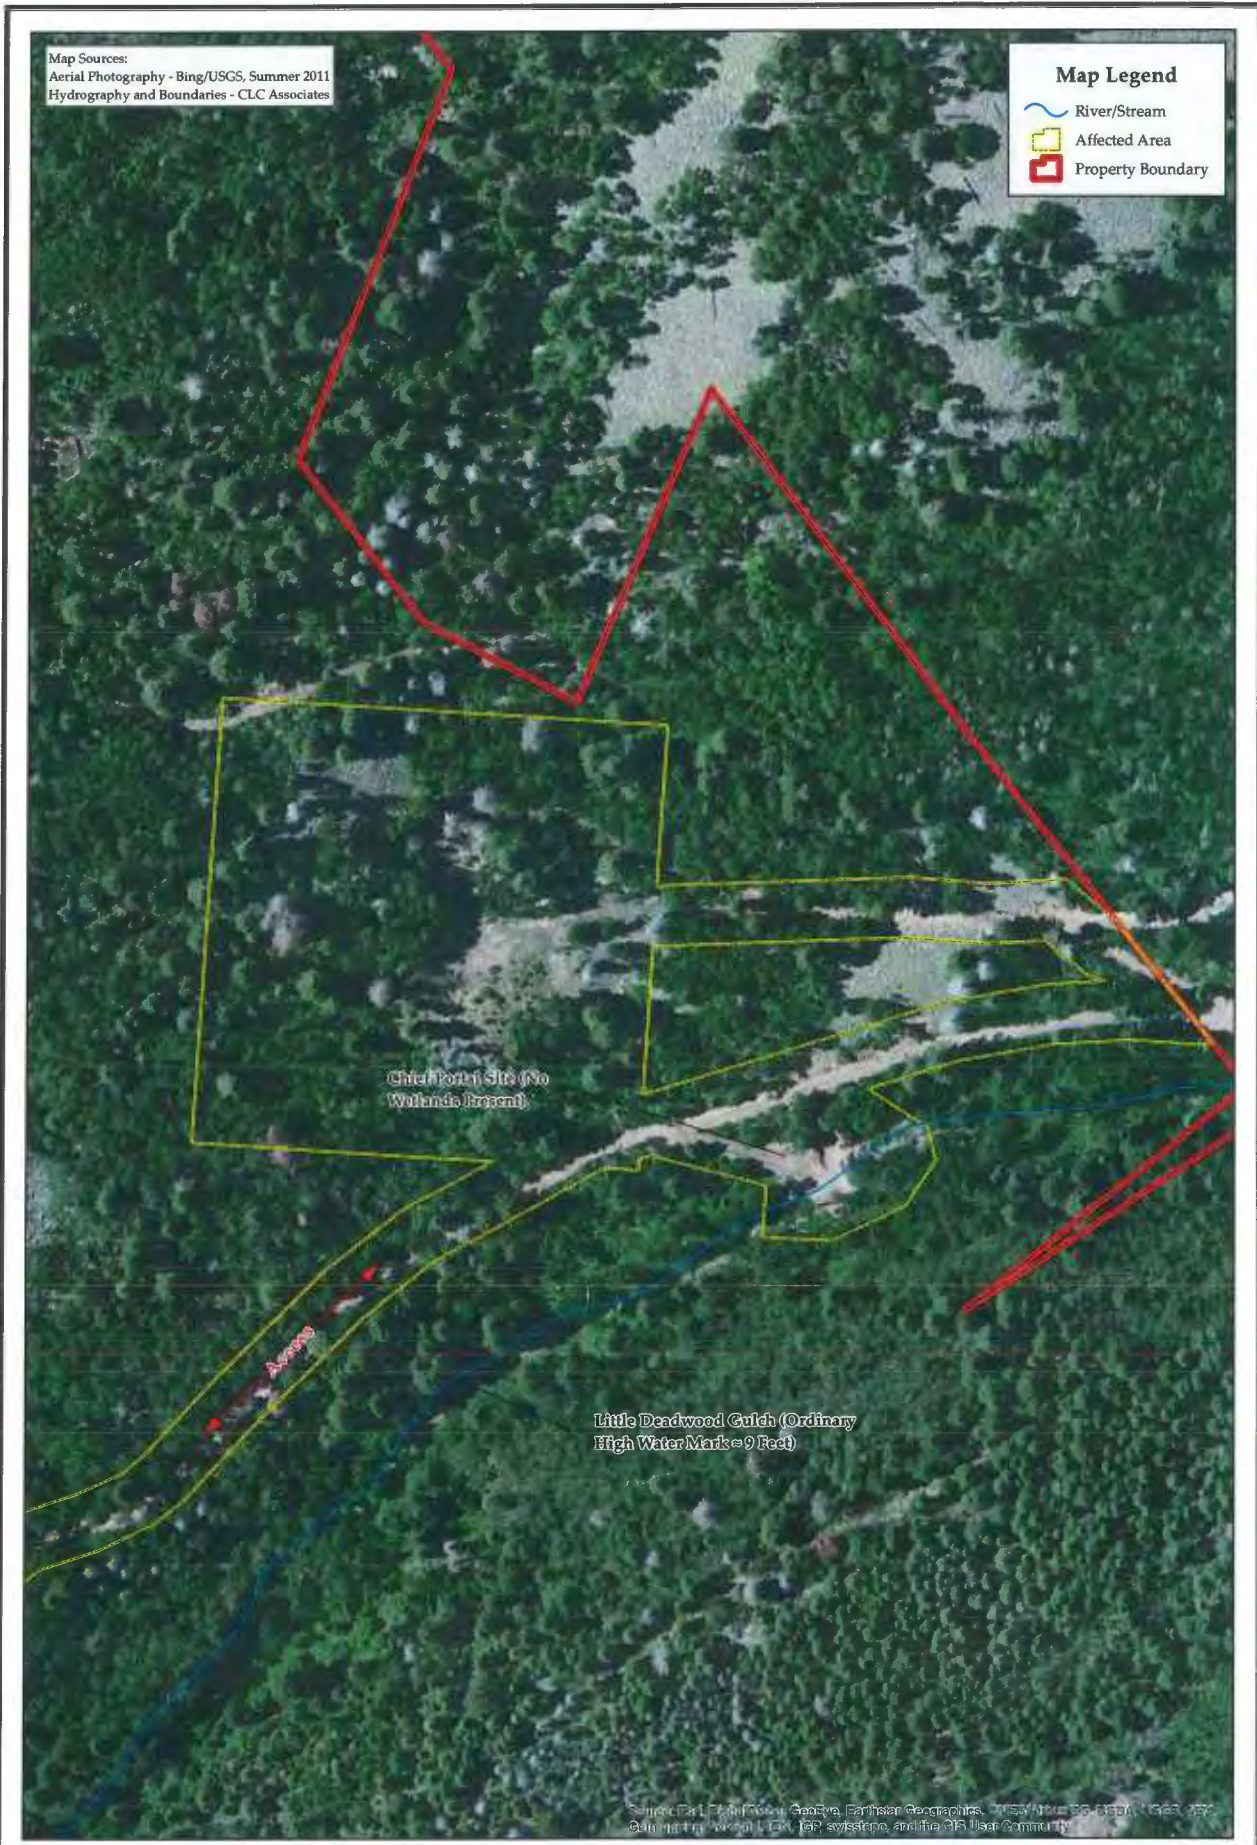
Figure
3B

May Day Mine
Existing Conditions At
Chief Portal Site

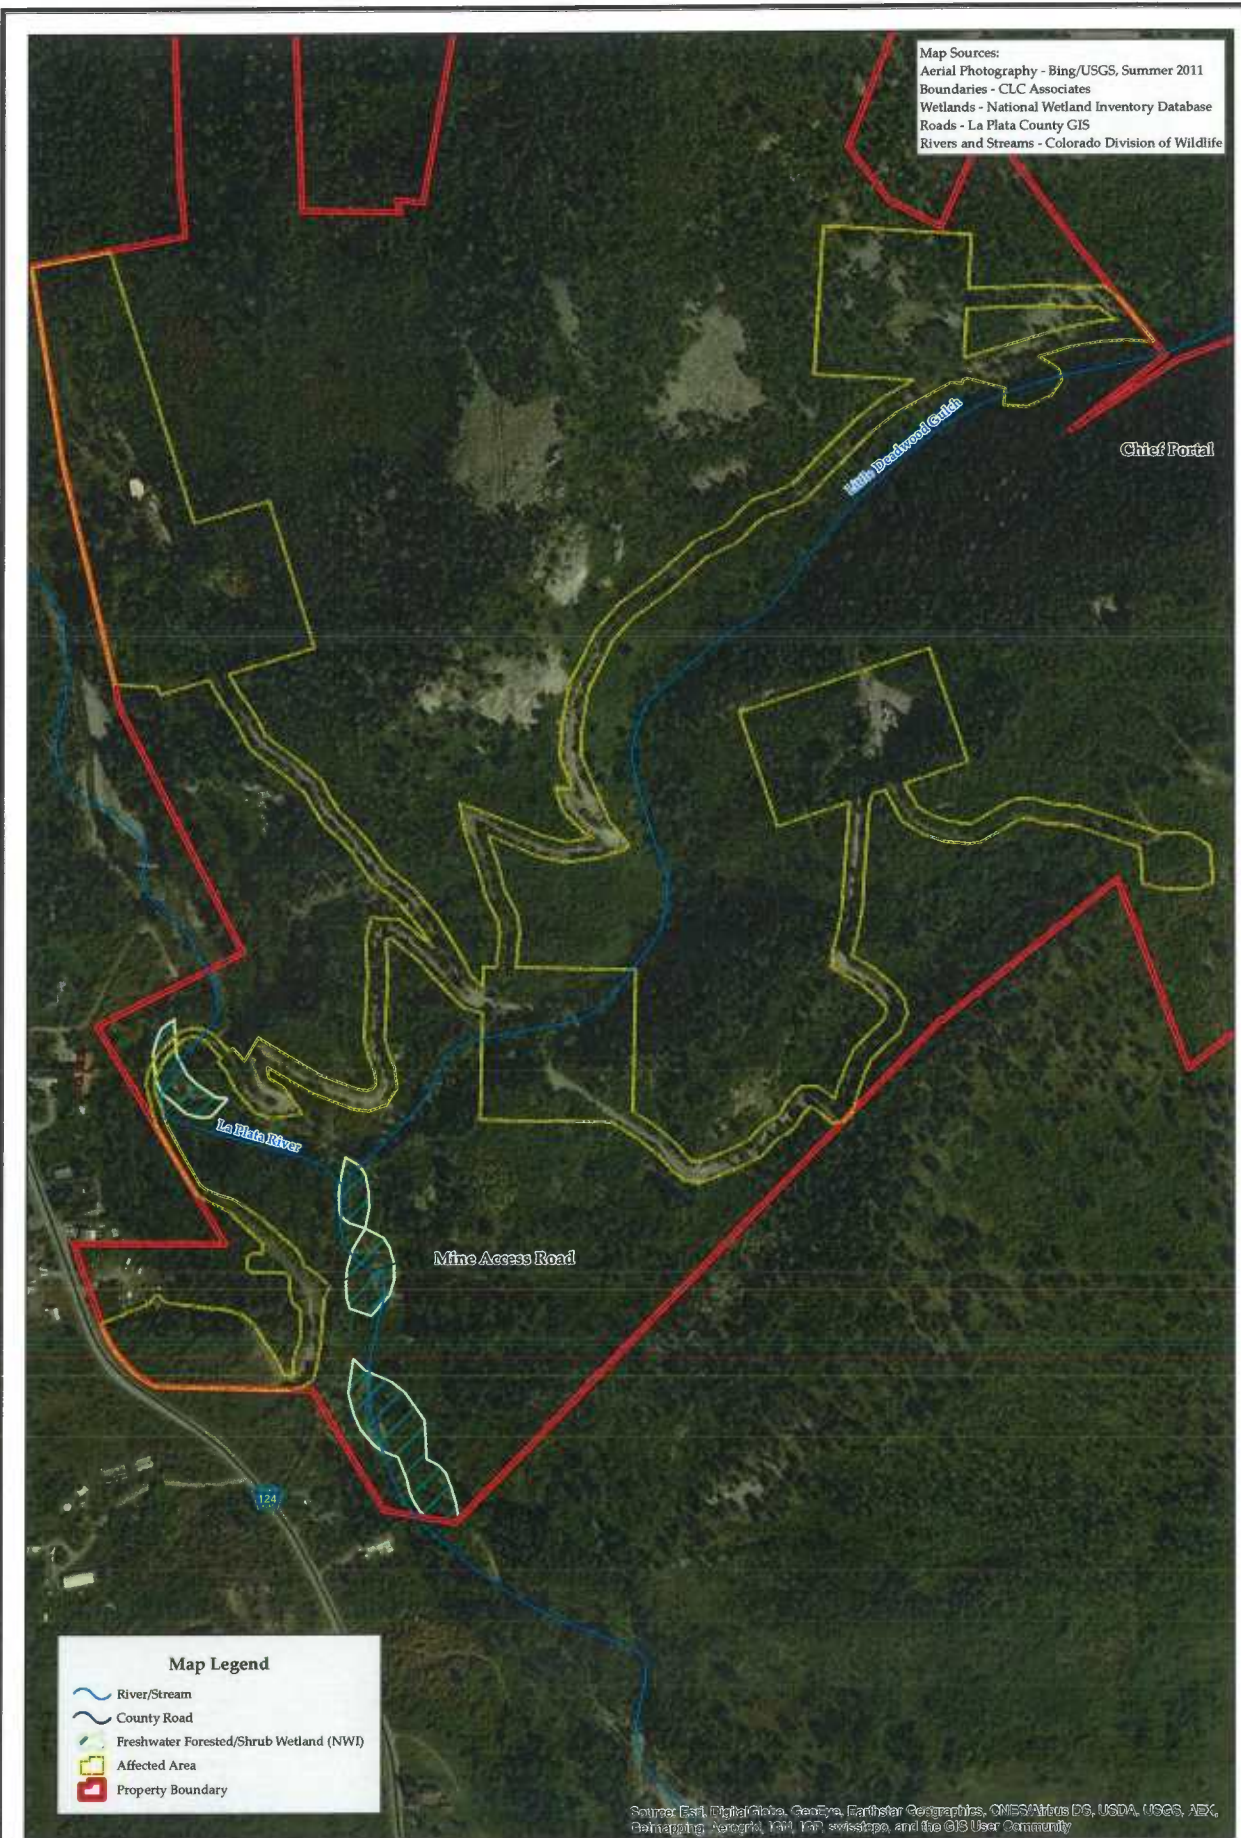
**Figure
 4**

**May Day Mine
 NWI Wetland Map**

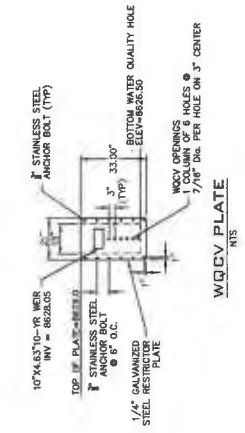
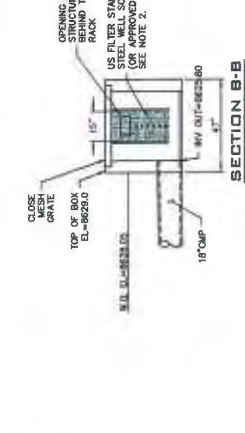
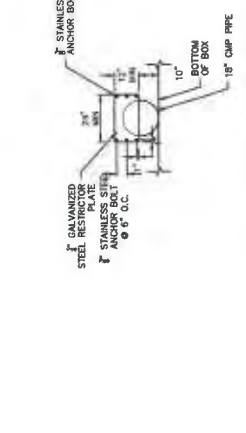
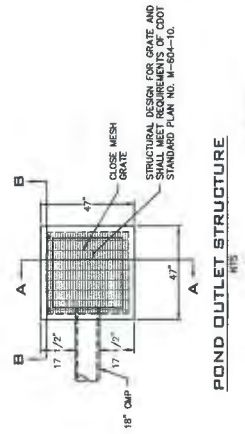
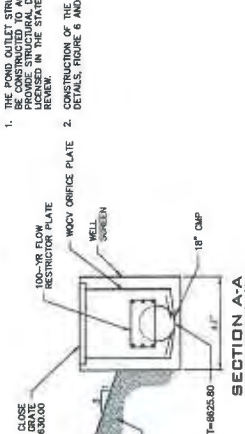
Figure 10B

NOTES:
 1. THE POND OUTLET STRUCTURE (TYPE "C" INLET) PER CDD STANDARD M-604-10 SHALL BE CONSTRUCTED TO ACCOMMODATE A CLOSE MESH GRATE. THE MANUFACTURER SHALL PROVIDE A STRUCTURAL DESIGN FOR GRATE AND SHALL BE REVIEWED BY THE CDD STANDARD PLAN NO. M-604-10.
 2. CONSTRUCTION OF THE WELL SCREEN SHALL CONFORM TO URBAN DRAINAGE STANDARD DETAILS, FIGURE 6 AND FIGURE 6-a.

WATER QUALITY VOLUME	VOL (AC-FT)	WSL (FT)
10-YR VOLUME (INCL WQ)	0.051	8629.05
100-YR VOLUME (INCL WQ)	0.160	8630.0
FREEDBOARD*		8631.0

DETENTION POND OUTLET STRUCTURE DETAILS

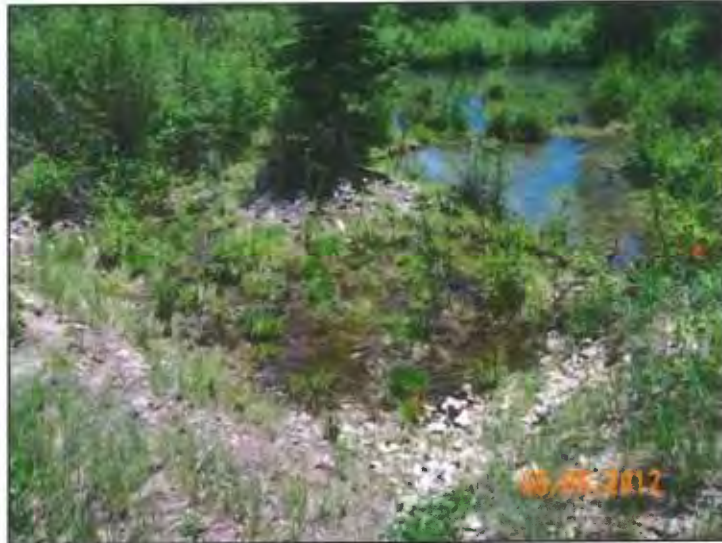
Photo 1. Emergent mitigation wetland.

The mitigation sites were observed by BWC on June 5, 2012. The percent cover of the emergent wetland site was approximately 80 percent, with all plants being wetland species and the non-vegetated area consisting of shallow open water. Photos 1 to 3 in Appendix B show the condition of the emergent wetland mitigation area. The survival rate for the scrub-shrub wetland was 79 percent, though most growth was basal re-sprouting. The understory of the scrub-shrub wetlands was sparse and consisted mainly of litter (see Photos 4 to 6 in Appendix B). The success criteria and observations of the mitigation site are summarized in Table 1. The observations indicate that the emergent wetland site has met the success criteria and, while the survival rate is relatively high, the growth of the willows at the scrub-shrub site is less than robust. A 2012 Annual Wetland Mitigation Monitoring Report was prepared by BWC and provided to the USEPA and Corps.

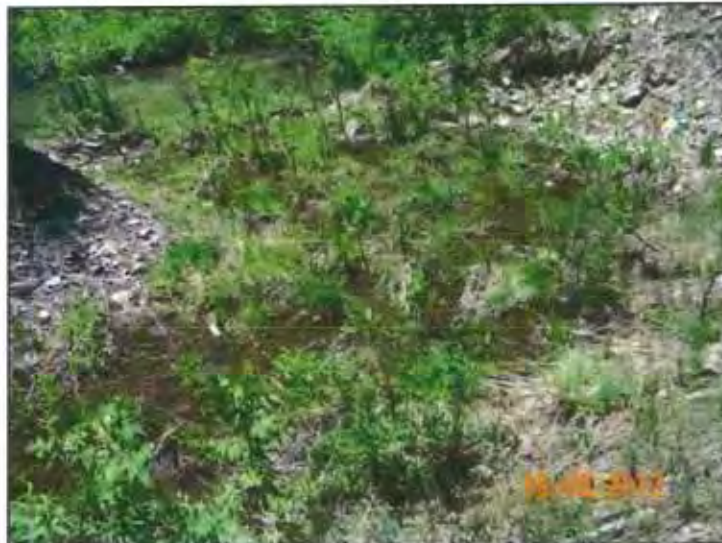
Photo 2. Close-up of emergent mitigation wetland showing excellent growth of willows and emergent species.

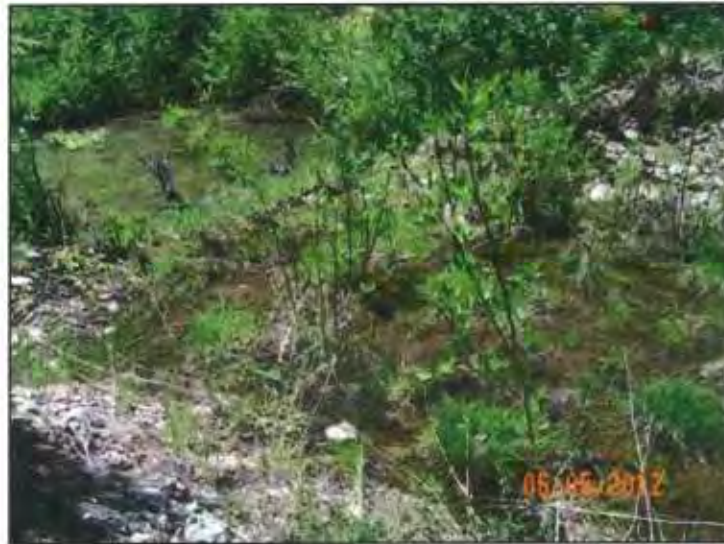
Photo 3. Close-up of emergent mitigation wetland showing excellent growth of willows and emergent species.

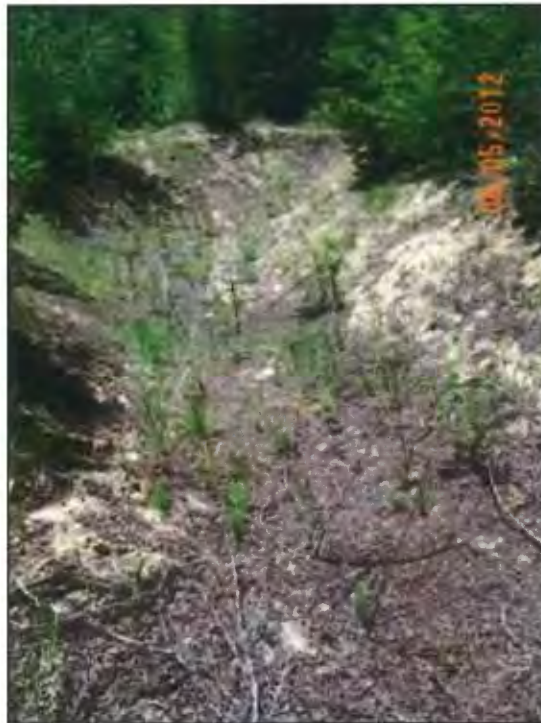
Photo 4. Scrub-shrub mitigation wetland. Note willow growth with sparse understory.

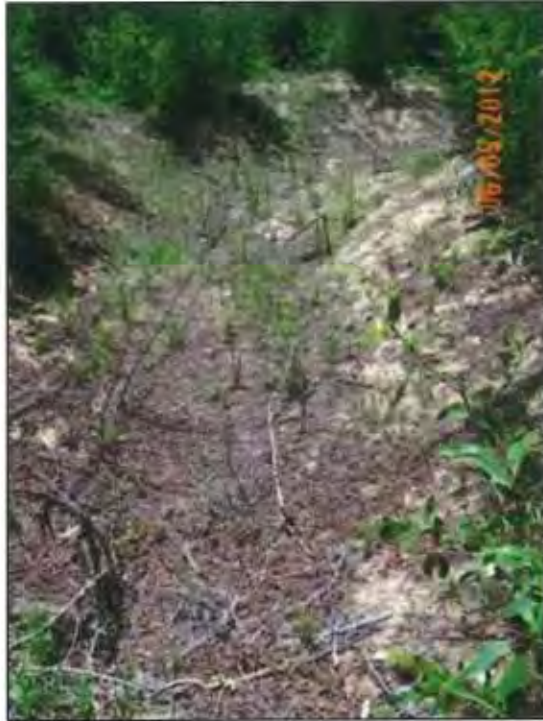
Photo 5. Scrub-shrub wetland looking south. Note viability of planted willows.

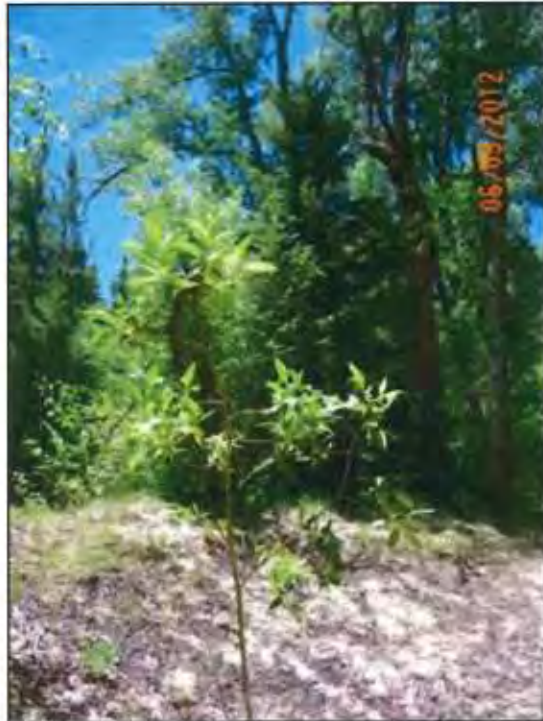
Photo 6. Close-up of planted willow showing recent growth

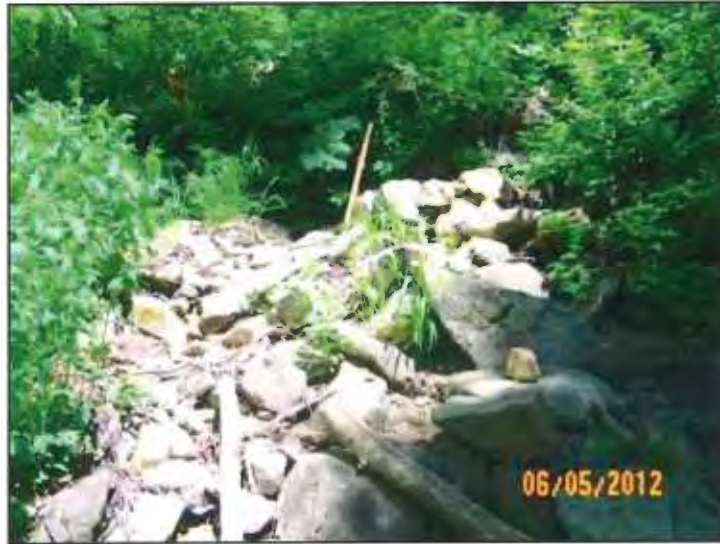
Photo 1. Little Deadwood Gulch channel upstream of the Chief Portal.

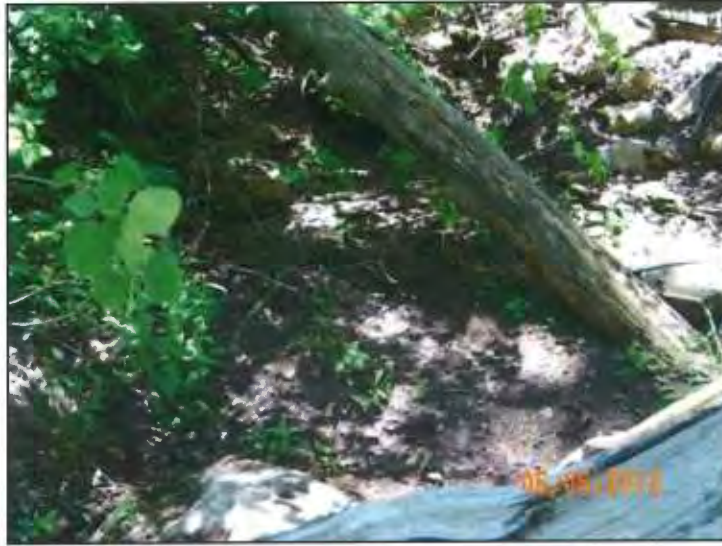
Photo 3. Channel upstream of historical fill at old culvert. Note sediment deposit.

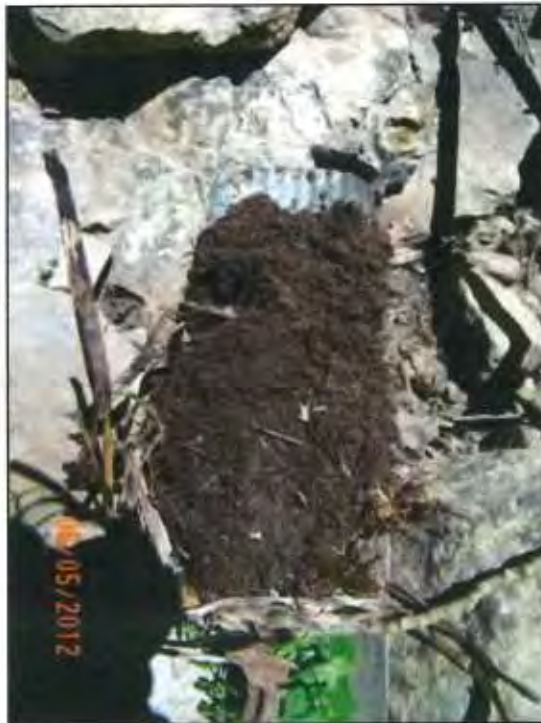
Photo 4. Loamy, well-drained soil along Little Deadwood Gulch channel. The soil lacks hydric indications.

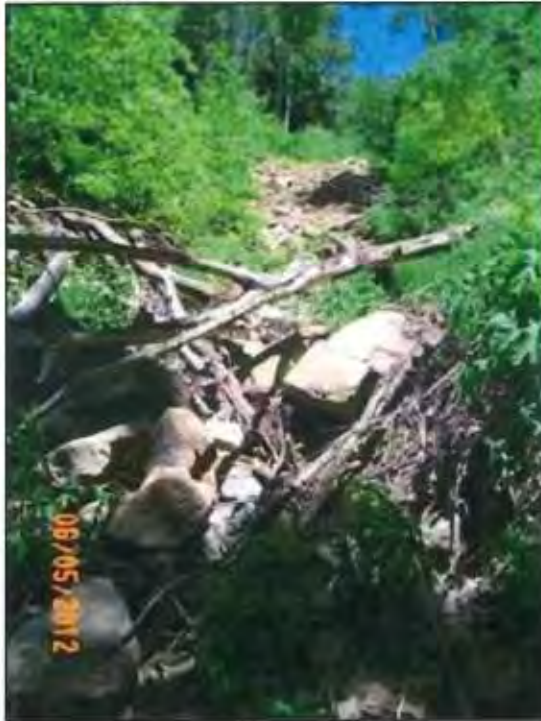
Photo 5. Channel downstream of Chief Portal. Note the abundant woody material.

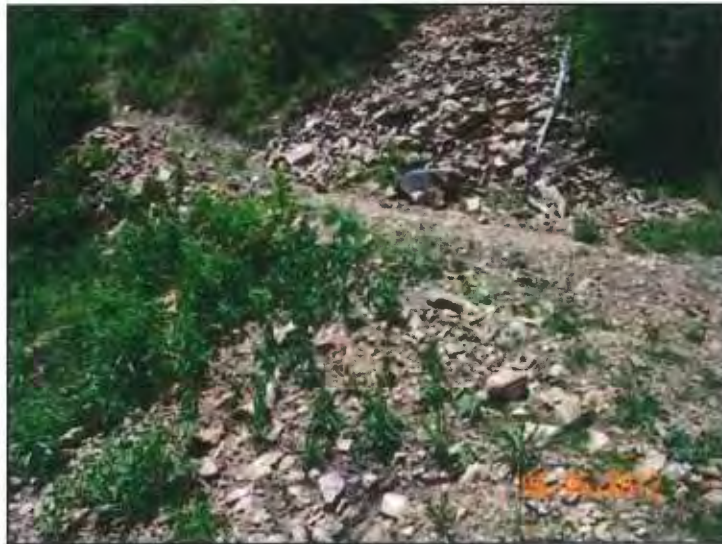
Photo 6. Access road down to the Chief Portal. The Portal is off the photo to the lower right.

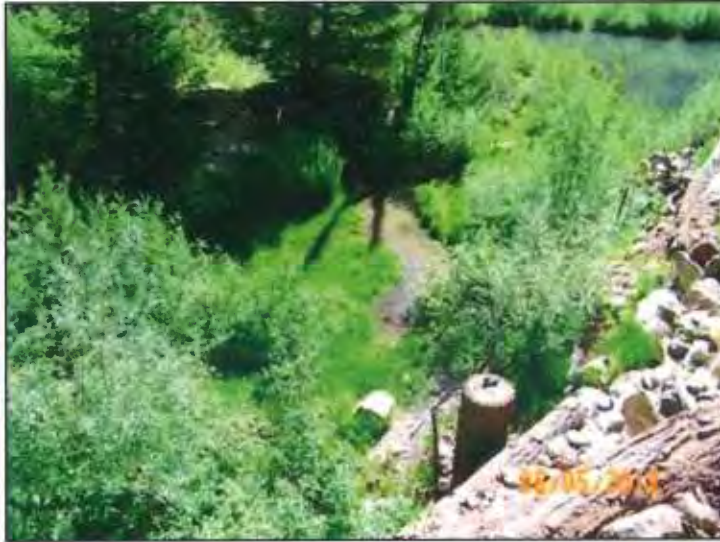
Photo 7. Wetland dominated by willows and horsetail at toe of existing mine access road. (see WDDF 2 in Appendix D).

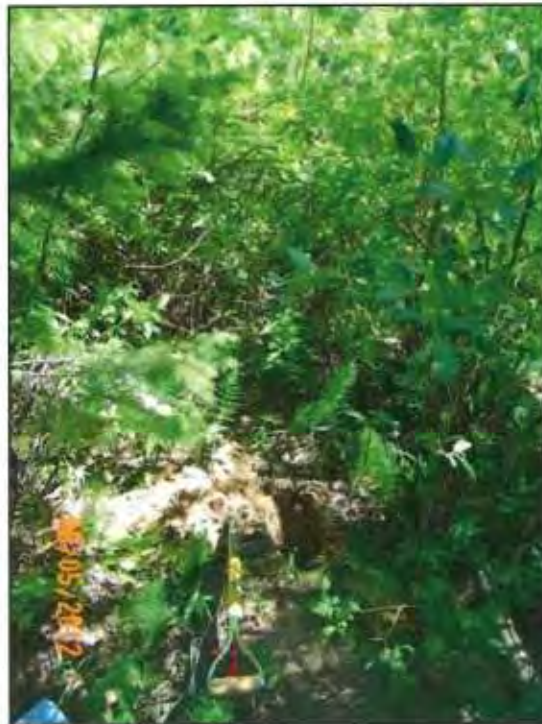
Photo 8. WDDF _ in scrub-shrub wetland. Note light-colored tailings.

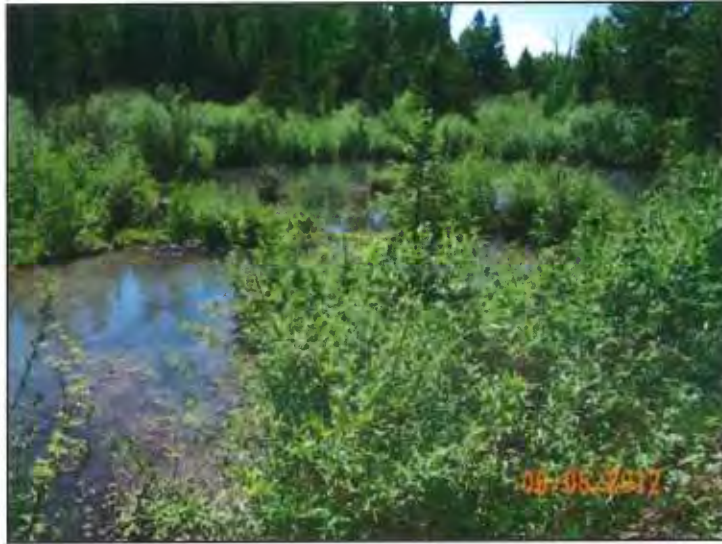
Photo 9. Scrub-shrub wetland associated with beaver ponds between the La Plata River and the existing mine access road.

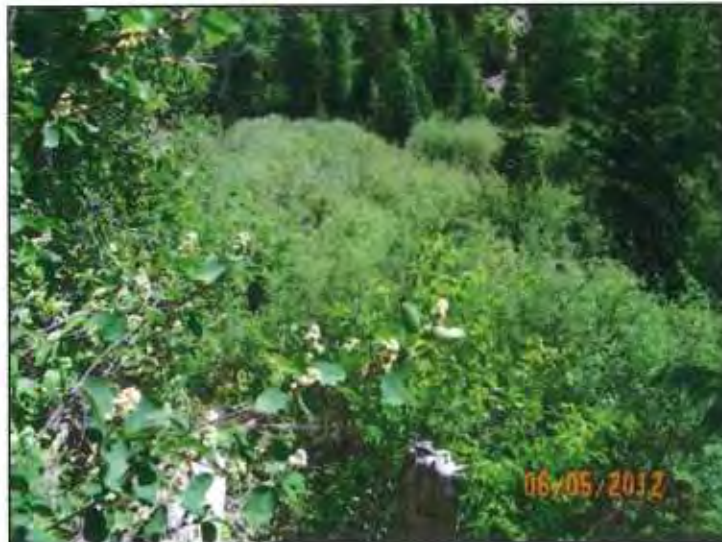
Photo 10. Riparian scrub-shrub wetland south of the existing mine access road.

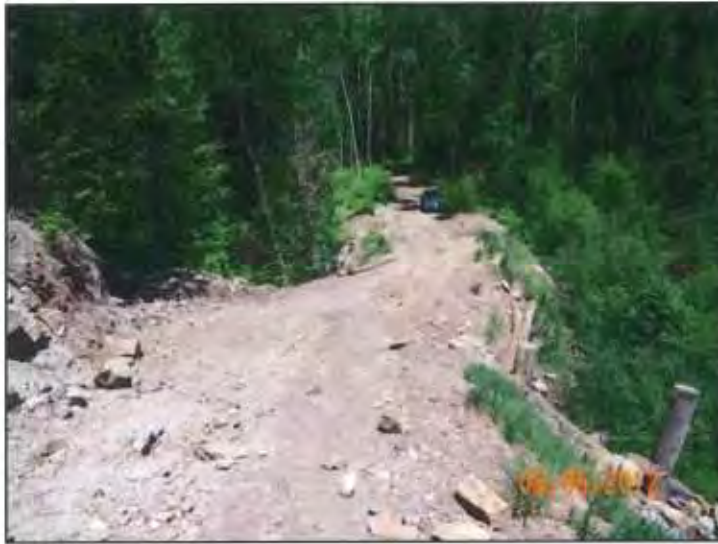
Photo 11. Crossing authorized under NWP 14 with cottonwood forest in the background.

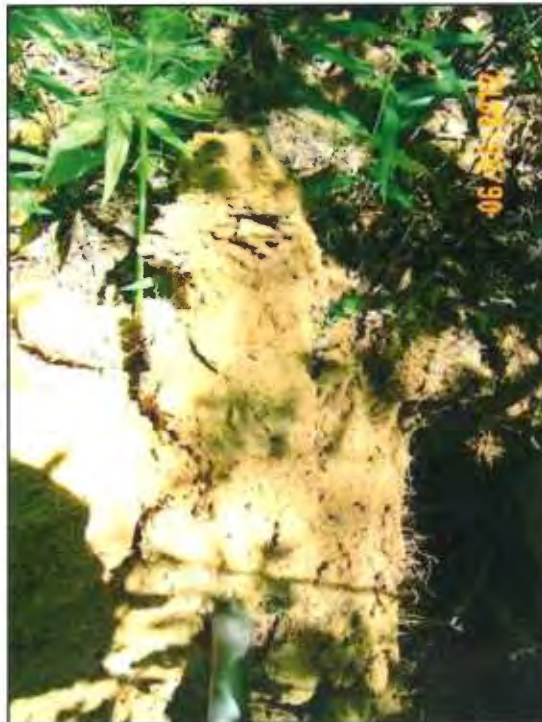
Photo 12. Close-up of mine tailing at WDDF _.

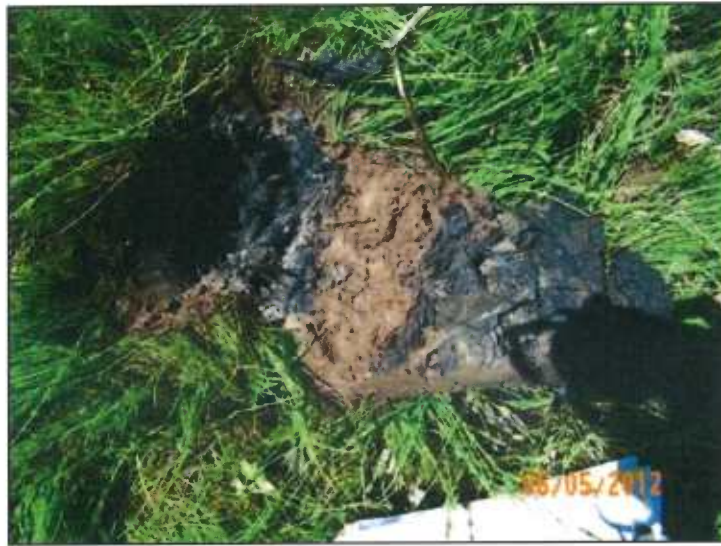
Photo 13. Close-up of soil at WDDF _.

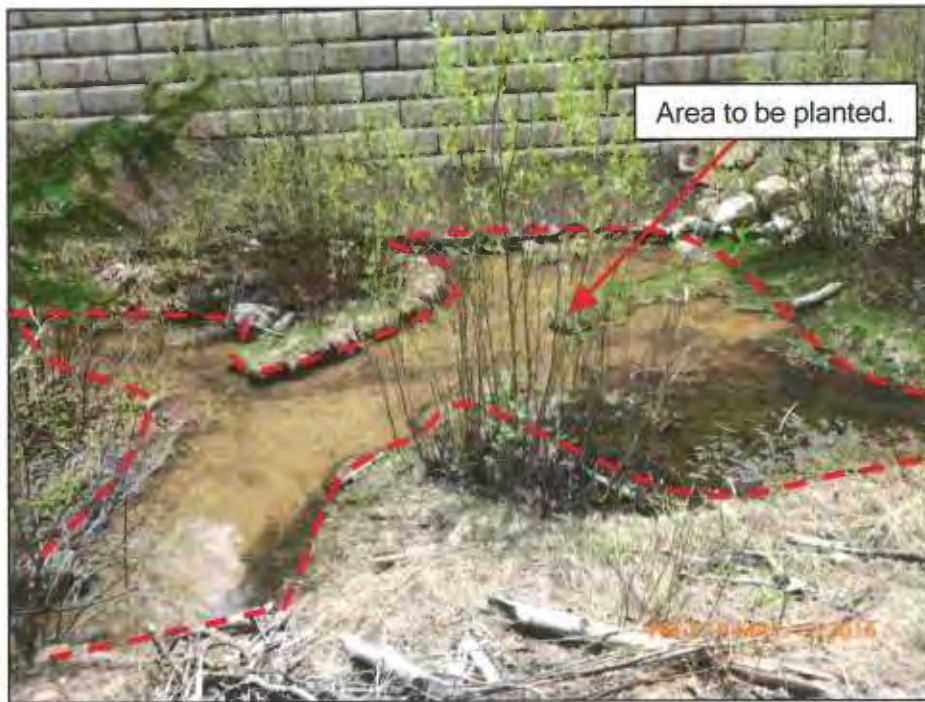
Photo I-4. Area C with retaining wall in background.
